Analysis of Damage and Repairs to the Transmission Part of the Komatsu Type GD825-2 Grader Unit

Abstract. The Plant Rebuild Center, owned by PT. X, must raise quality to meet customer expectations and fulfill field needs. According to customer warranty claims in 2022, oil leaks in the transmission control valves of GD825-2 type units—11 in total—are the most common cause. This research's operational goal is to identify the source of the most damage to transmission components, particularly in Komatsu GD 825-2 units that corrective action may be taken and the effects can be monitored. At PT X's Plant Rebuild Center, corrective measures were implemented and standard operating procedures were created to serve as a guide for rebuilding Komatsu GD 825-2 unit transmission components. The analytical approach applies five why analyses. The findings show that oil leaks in the transmission control valve are the most common cause of damage. The engineering techniques used to achieve this improvement included duplicating the sleeve using the manufacturer's standard reference and altering the o-ring seat height during the semi-finishing stage before measuring and cutting during the finishing pr

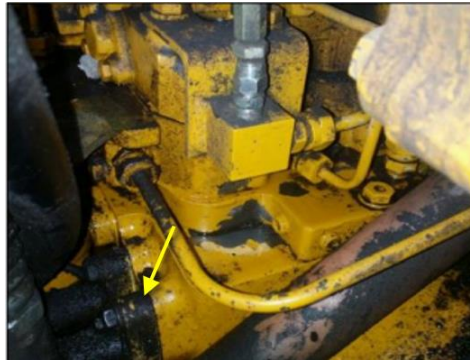
Figure 4. Oil leak at the GD825-2 transmission control valve

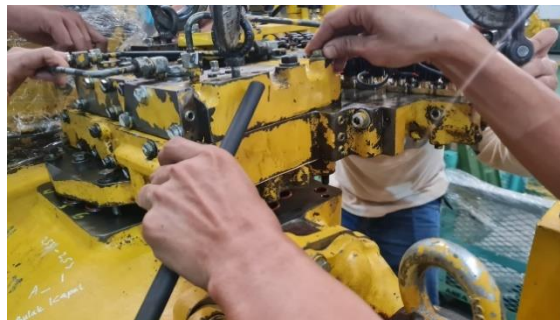
Figure 5 process of dismantling the transmission control valve from the transmission housing, to identify leakage problems that occur.

Figure 5. Removal of transmission control valve from transmission housing

To clearly understand the cause of the oil leak in the transmission control loop, a failure component demolition is performed. This transmission uses a system where the oil is moved using a transmission control valve through the oil's track in the transmission housing, with the oil's pressure measuring either 1.47 Mpa or 15 kg/cm² [19]. As a result, appropriate feedback needs to be given to the aforementioned gaps. The first step involves the transmission control loop assembly from the housing unit [20]. Following the breakdown of the transmission control unit, a failure was observed on the o-ring that had rusted through the sleeve. This resulted in the o-ring being unable to be properly seated and caused an oil transmission to break free from the individual transmission unit and housing.

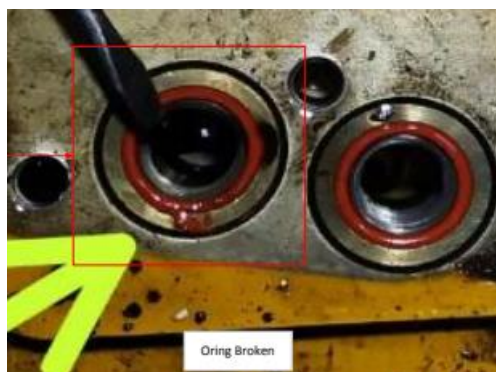
Figure 6 identifies the next focus on the sleeve, this is because the o ring that is damaged is only the part that sits on the sleeve.

Figure 6. O-ring's findings on the damaged sleeve

Focus identification on the sleeve, as this is caused by an o-ring that experiences failure only on the sleeve's upper surface. The analysis process on the sleeve itself involves identifying the difference in sleeve surface area and transmission housing surface area.

The o-ring installed on the sleeve was found to have non-standard results from the Compression Set and Squeeze measurements. This led to the o-ring being less effective in the pressurized oil sealing process, causing the installed o-ring to be damaged quickly and pressurized oil to escape through the gaps. o-ring distance.

The analysis of the disassembly process revealed that wear on the contact area between the transmission housing and the sleeve was the reason for oil leakage from the transmission control valve. This led to an abnormally large gap between the sleeve and the transmission control valve's surface, which reduced the O-ring's process insulation effectiveness. To prevent oil leaks in the transmission control valve, it is necessary to make efficient repairs to the sleeve and seat.

A repair plan is made once the problem's core cause has been identified. Engineering must be corrected to get the sleeve's surface back to being flush with the transmission housing's surface. Here's a more practical and efficient method:

- a. Producing duplicate sleeves based on standard sleeve sizes and altering the O-ring holder's height, or what is commonly referred to as a semi-finished product (semi-finishing).
- b. Create a standard protective sleeve by making a standard protrusion on the transmission housing's surface.

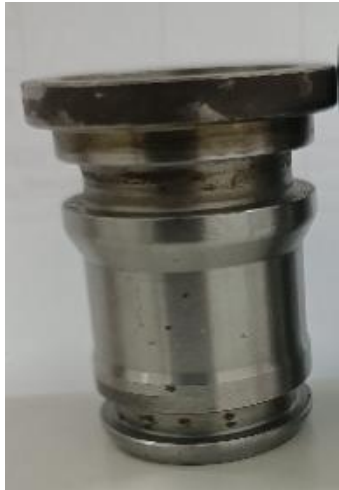
Figure 8. Sleeve before repairs

Figure 8 results of material hardness measurements on the original sleeve 32.2 Hrc, with a height of 4 mm. Figure 9, the second sleeve's dimensions are raised by 7 mm. This puts the sleeve in a vulnerable position that will be machined using a lathe. Following the halfway completion of the duplicate sleeve, the depth measurement results indicate the next step in the repair process, the hardness test 32.5 HRC

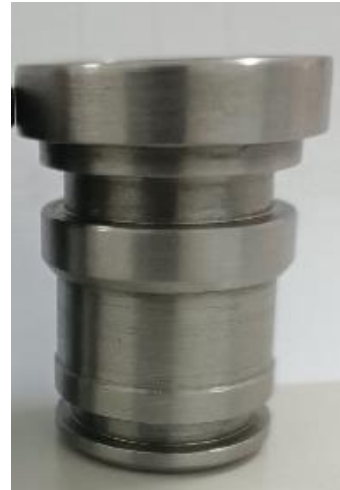
Figure 9. Sleeve after repairs
