Windshield Damage Analysis on ATR 42/72-600 Aircraft at PT. DEF

Abstract. Windshield damage on ATR 42/72-600 aircraft at PT. DEF has caused operational disruptions, including flight delays, increased maintenance costs, and potential safety risks. Repeated damage to the Windshield is caused by various factors, namely inspection and maintenance errors, improper installation procedures, damage to the heating system or pressure distribution, glass material degradation, and exposure to extreme weather and UV rays. In this study, the analysis was carried out using a quantitative method with a fishbone diagram to identify the main causes of damage and appropriate mitigation steps. The results of the analysis showed that the main factors contributing to the damage were errors in inspection, installation errors, and material degradation. After implementing mitigation steps such as improving technician training, revising maintenance procedures, and improving material selection, there was a significant decrease in the frequency of Windshield damage. An indication of the success of these mitigation steps can be seen from the repairs carried out during January to June 2024 which succeeded in r

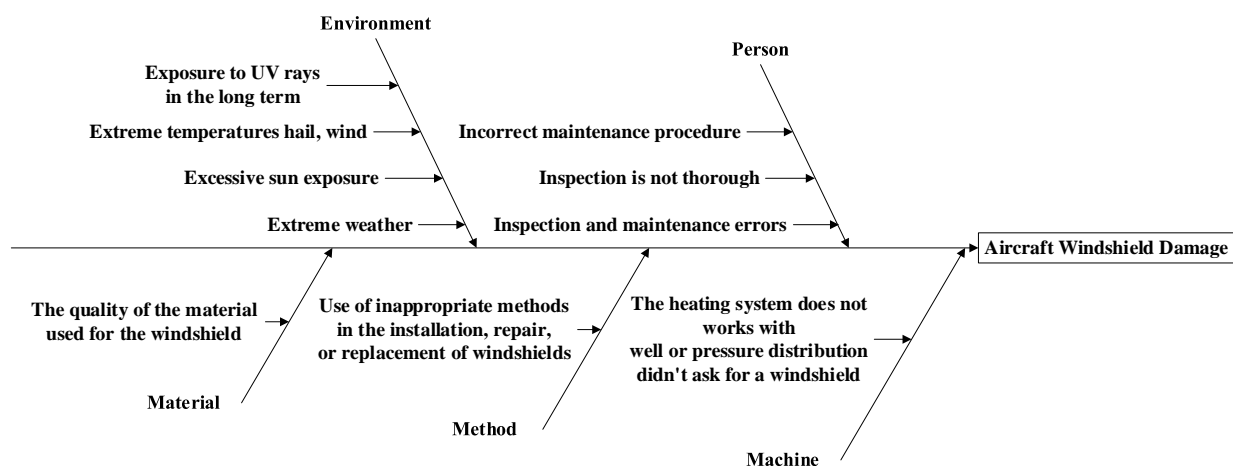
Figure 2. Fishbone diagram

Figure 2 explains the factors causing damage to aircraft windshields, based on the fishbone analysis shown in the diagram, which can be explained as follows:

- **Human Factor (Inspection/Maintenance Errors):** Mistakes made by technicians or maintenance staff in performing routine inspections and maintenance on the Windshield can be the cause of damage. For example, careless inspection or incorrect maintenance procedures can result in damage or failure to detect problems on the Windshield in a timely manner. Proper Repair and Maintenance include: a) Routine and Thorough Inspection: Aircraft Windshield maintenance requires routine inspections to detect potential damage. The application of visual and non-destructive methods (e.g., ultrasonic testing) is essential to find micro-cracks or material degradation that may not be visible to the naked eye. b) Technician Training: All technicians involved in Windshield maintenance must receive adequate training and certification. Procedural errors often occur due to lack of technical understanding, so periodic training is necessary to ensure compliance with applicable standards. c) Heating System: Periodic inspection of the heating system function is crucial. A heater that is not working optimally can cause the Windshield to experience thermal stress. Thermography or temperature sensor inspection can be used to ensure even heat distribution.

- **Method Factors (Improper Procedure):** Using an improper method in installing, repairing, or replacing the Windshield can cause damage. Incorrect handling procedures can create excessive stress, improper installation, or non-compliance with applicable safety standards. Proper Methods include: a) Windshield Replacement Procedure: Installation and replacement of the Windshield must follow standard procedures established by the aircraft manufacturer and aviation authorities. The use of proper tools (such as torque wrenches for tightening bolts) and testing after installation are mandatory steps to ensure that there is no excessive stress on the Windshield. b) Pressure and Temperature Measurement Standards: The use of accurate pressure and temperature

- **Material Factors (Quality/Degradation):** The quality of the material used for the Windshield, if inadequate or degraded over time, can affect its resistance to air pressure, extreme temperatures, or exposure to ultraviolet (UV) light. Materials that do not have high resistance to operating conditions can experience cracking or other damage. The Recommended Lifespan of Aircraft Windshield Materials is usually dependent on several factors, including material quality and operating conditions. However, in general: a) Laminated Windshield Glass: The average recommended life span is 4 to 5 years, depending on exposure to environmental factors such as UV light and extreme temperatures. b) Windshield Heating System: The heating components need to be checked and serviced regularly. The life span of the heating system is approximately 2 to 3 years, depending on usage and maintenance conditions. c) After this life span, a thorough inspection should be performed to ensure the structural integrity of the Windshield and replace if necessary.

- **Engine Factors (Heating System/Pressure Distribution):** Aircraft windshields are often equipped with a heating system to prevent dew or ice. If the heating system is not functioning properly or the pressure distribution is uneven on the Windshield, this can trigger damage, such as cracking or breaking due to changes in temperature or unbalanced pressure.

- **Environmental Factors (Extreme Weather/UV Exposure):** Extreme weather, such as excessive sun exposure, extreme temperatures, hail, or high winds, can accelerate the degradation of the Windshield material. Long-term exposure to UV rays can also damage the structure of the glass material, reducing its durability and increasing the risk of cracking. Environmental factors greatly affect the service life and condition of the Windshield material. Standards that need to be considered include: a) Operating Temperature: The Windshield must be able to withstand extreme temperature changes ranging from -50°C to 50°C. This refers to the temperature that can be experienced during flight, from low altitude to very high cruising altitude. b) UV Exposure: The Windshield must have high resistance to ultraviolet light exposure. The material is designed to protect against 99-100% of UV rays to reduce long-term degradation. c) Air Pressure: The windshield must be able to withstand a significant pressure difference between the cabin interior and outside the aircraft of up to 6.35 psid and the outside air pressure at an altitude of 25,000 feet is 10.91 psi (8,000 feet Cabin Altitude) approximately 30-40% of the air pressure at sea level which is 14.7 psi [17].
