## Analysis of Damage to The Induce Draft Fan Component at PLTU. XYZ

Wilarso\*, Awang Surya, Asep Saepudin, Muhamad Ali Pahmi

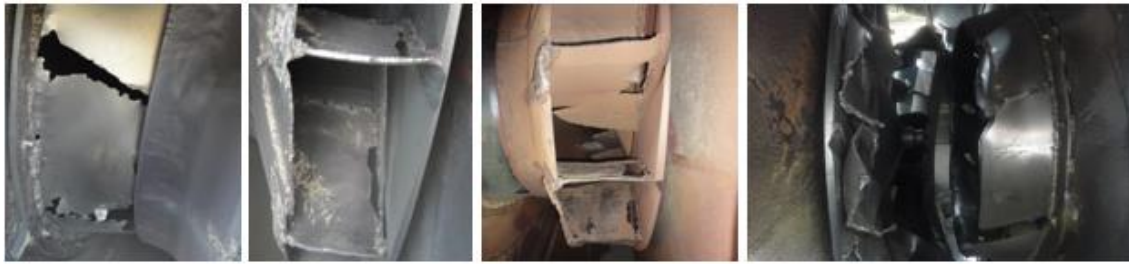
Analysis of the generating unit's operational records indicates that approximately 61% of total unplanned shutdowns were attributed to eight incidents of Induced Draft Fan (IDF) failure, resulting in an estimated loss of 911 operating hours. The predominant failure mechanism involved progressive erosion of the fan blade and cone surfaces caused by continuous impingement of fly ash particles. Over time, this erosive wear led to perforations on the blade plates and cone body, which consequently reduced the fan's suction efficiency and disturbed the aerodynamic balance of the system.

The resulting imbalance produced excessive vibration levels, contributing to secondary mechanical failures, including bearing wear and v-belt deterioration. These cascading effects significantly impacted unit reliability and maintenance frequency. Figure 1 illustrates the observed damage morphology on the fan blade and cone components recorded during 2013.

**Figure 1.** Faulty IDF fan blade and cone

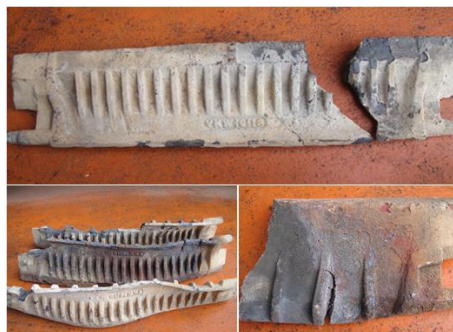
The stoker boiler with a traveling fire grate used at PLTU Nagan Raya is under the specifications of the coal (lignite) used as fuel. This type of boiler can accommodate the combustion of high to low-quality coal. However, coal is used with an ash content of 8.23% [9], which is lower than required, which is between 10-15%, causing the ash layer to form on the grate to be less than 5cm. This caused the damage to the grate bar with an average occurrence of 40 pcs per month Figure 2 during 2013. This damage did not cause the operation of the generating unit to stop, because grate bar replacement could be carried out while the boiler was operating.

**Figure 2.** Failed grade bar

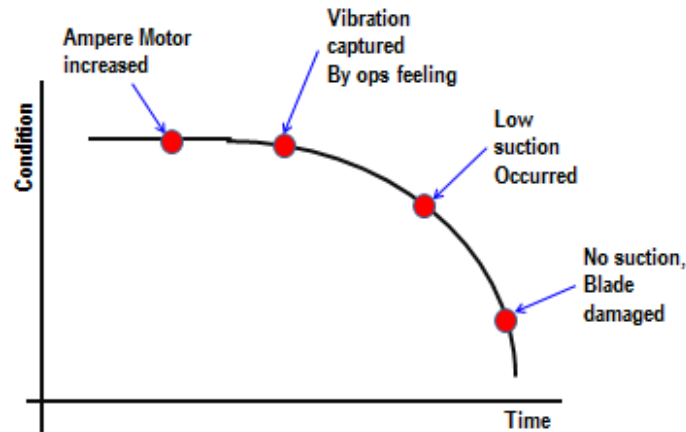
IDF damage begins with an increase in amperage on the electric motor or the motor experiences an overload. This condition was discovered during routine inspections. Damage occurs when the rated ampere is 470 Ampere to 490 Ampere either constantly or hunting. This increase is the result of abrasion on the fan blade so that the blade rotation against the shaft becomes unbalanced. Increasing the ampere in the electric motor will develop a vibration that can be felt by the operator. If the vibrations that occur are not followed up, the IDF's performance will decrease until physical damage occurs to the fan blade and the IDF casing. IDF final failure will also damage the bearing, bearing housing, and v-belt. The IDF damage curve is shown in Figure 3.

Figure 3. IDF deterioration curve

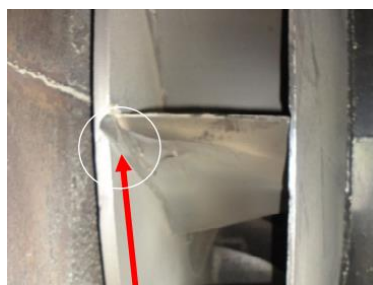
The damage observed on the Induced Draft Fan (IDF) blades is primarily caused by continuous exposure to combustion dust that was not captured by the non-functioning Electrostatic Precipitator (ESP). The main types of damage identified are abrasion and perforation, as shown in Figure 4.

Abrasion occurs when high-velocity fly ash particles—containing hard minerals such as  $\text{Fe}_2\text{O}_3$ ,  $\text{SiO}_2$ , and  $\text{Al}_2\text{O}_3$ —continuously collide with the fan blade surface [10]. Over time, this erosive contact removes the protective oxide layer and reduces the blade's thickness, particularly along the leading edge where airflow velocity is highest. Once the material loses sufficient cross-sectional strength, localized thinning evolves into perforation, forming holes on the blade surface.

Figure 4a. IDF abrasion blade

Abrasion in the Induced Draft Fan (IDF) occurs due to continuous collision between fly ash particles and the fan blade surface [11]. The fly ash contains approximately 12.6–14.2%  $\text{Fe}_2\text{O}_3$ , which possesses high hardness and angular particle shapes, intensifying the erosion effect. Under high-velocity gas flow conditions, these particles strike the blade surface at various impingement angles, causing micro-cutting, surface roughening, and gradual material loss [12].

The problem is further aggravated by the non-functioning Electrostatic Precipitator (ESP), which fails to capture the fly ash effectively. Consequently, the concentration of abrasive particles in the flue gas increases, exposing the IDF blades to prolonged erosion [13]. The continuous reduction of blade thickness alters the aerodynamic profile and induces imbalance, leading to excessive vibration and reduced mechanical efficiency. Over time, these combined effects can cause severe mechanical damage and shorten the operational life of the IDF system [14].

In summary, the root mechanism of damage is erosive wear due to high fly ash loading in the flue gas, worsened by the absence of ESP operation. Long-term mitigation should include material selection improvements (e.g., wear-resistant coatings), optimization of gas flow velocity, and ensuring continuous ESP reliability to reduce particulate concentration entering the IDF.

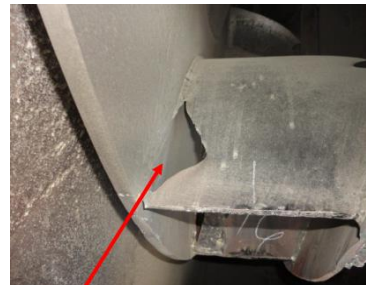
The perforation indicates a severe stage of material degradation, where the metal has lost its structural integrity. This type of damage alters the aerodynamic balance of the fan, increases vibration amplitude, and leads to mechanical instability. If left uncorrected, it can propagate into shaft imbalance, bearing overload, and even catastrophic fan failure.

Figure 4b. IDF perforated blade

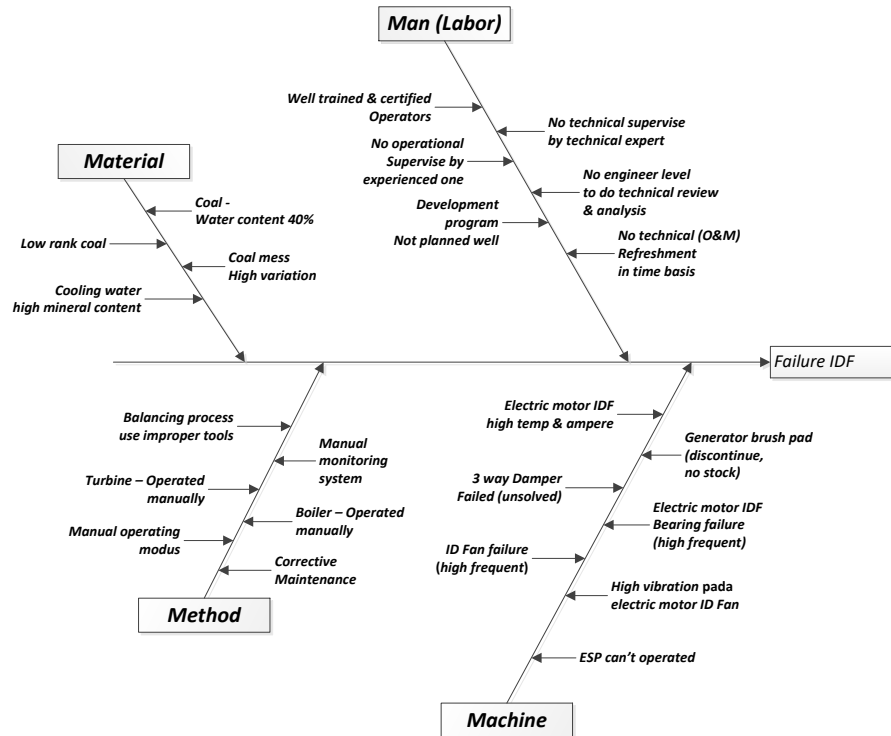
Evaluate the key operational issues affecting the performance of the PLTU Nagan Raya generating unit, a detailed assessment was conducted using the Fishbone (Ishikawa) Analysis method, as illustrated in Figure 5. This analytical framework was applied to identify both direct and indirect factors contributing to the unit's performance degradation and failure events. The Fishbone diagram helps visualize the interrelationship between technical, human, and operational factors that influence the reliability of the power plant. The outcome of the analysis indicates that these factors collectively impact the Operational and Maintenance (O&M) economics of the plant throughout 2013, particularly by increasing downtime frequency and maintenance costs. Based on the analysis, four main areas requiring attention were identified as the primary contributors to reduced efficiency and increased failure risk within the generating unit

Figure 5. Fishbone analysis
