Analysis of Damage and Repairs to the Transmission Part of the Komatsu Type GD825-2 Grader Unit

Abstract. The Plant Rebuild Center, owned by PT. X, must raise quality to meet customer expectations and fulfill field needs. According to customer warranty claims in 2022, oil leaks in the transmission control valves of GD825-2 type units—11 in total—are the most common cause. This research's operational goal is to identify the source of the most damage to transmission components, particularly in Komatsu GD 825-2 units that corrective action may be taken and the effects can be monitored. At PT X's Plant Rebuild Center, corrective measures were implemented and standard operating procedures were created to serve as a guide for rebuilding Komatsu GD 825-2 unit transmission components. The analytical approach applies five why analyses. The findings show that oil leaks in the transmission control valve are the most common cause of damage. The engineering techniques used to achieve this improvement included duplicating the sleeve using the manufacturer's standard reference and altering the o-ring seat height during the semi-finishing stage before measuring and cutting during the finishing pr

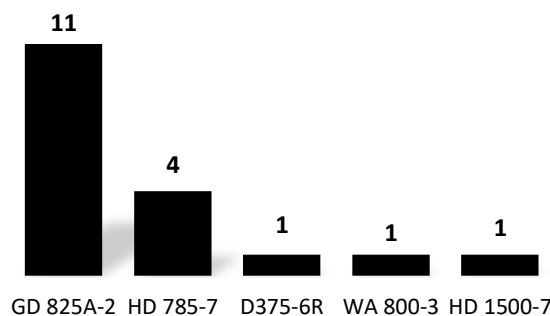
Figure 3. Graphic stating the transmission component's guarantee till 2022 [10]

Figure 3 indicates that the most frequently used transmission unit grader Komatsu with type GD825-2 is 11 cases. Due to this, a thorough analysis is required to specifically identify the type of failure that frequently occurs in the transmission component of the GD825-2 unit [11].

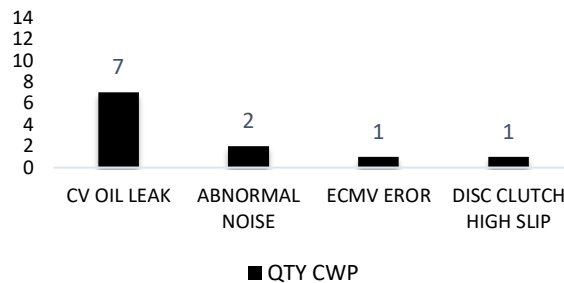
Figure 7. Partial schematic of the transmission component for the year 2022

Figure 7 indicates that the most common type of error that occurs in the transmission component of the GD825-2 is the mismatch in the valve transmission [13],[14],[15].

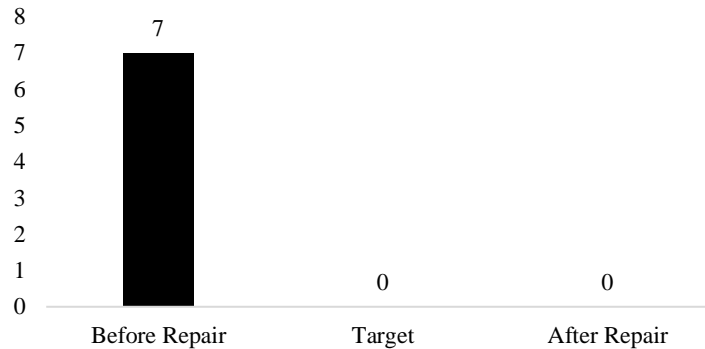
Figure 11. Graph following restoration

Subsequently, transmission damage data for the Komatsu GD825-2 unit type was compared with customer warranty claim data both before and during repairs. The outcomes are displayed in Figure 11.

Based on the conducted research, it can be stated that the Komatsu type GD825-2 grader unit's transmission section damage analysis and repairs were successful. Leaks of oil in the gearbox control valve are a common source of damage. The improvement was made by applying engineering techniques to ensure that the transmission housing and sleeve surfaces were identical. Specifically, the sleeve was duplicated using the manufacturer's standard reference, and the o-ring seat height was modified during the semi-finishing stage before being measured and cut during the finishing process. The procedure of measuring the protrusion of the sleeve surface on the surface of the transmission housing has been standard work at PRC PT. X and is incorporated into the standard operating procedure (SOP) in the form of a checklist assembly transmission unit grader type GD825-2 and Work Instructions (INK) to ensure that oil leakage damage to the transmission valve of the GD825-2 unit does not occur again. Install the GD825-2 unit's transmission valve transmission.
